The Monroe Preservation Primer: Guidelines for Rehabilitation and New Construction

**The City of Monroe
and
The Monroe Historic Preservation Commission**

**Jaeger/Pyburn
Gainesville, Georgia**

September 1987

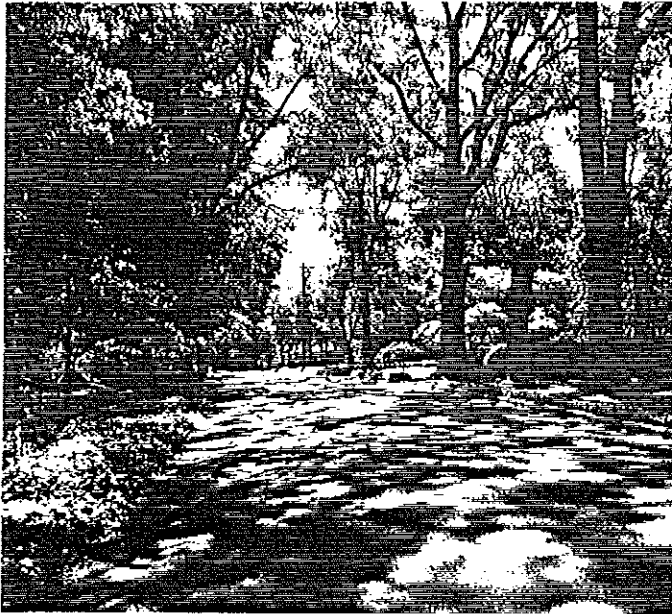
North Broad Street Historic District

Description - The North Broad Street district is essentially a turn-of-the-century middle and upper-middle class residential area. A few earlier houses exist, usually fine Greek Revival and Victorian era structures. Most of the buildings are frame and brick, two-story residences, sited on large lots. Classical and colonial styles predominate the area. The area was developed as a residential neighborhood on the north side of the central business district. The district is fairly unified in nature. Streets are generally laid out in a gridiron pattern, although both North Broad Street and North Midland Avenue curve at their northern end. Block sizes are not uniform and lots are generally large, except along the eastern side of North Broad Street. These buildings are closer together with more "urban" characteristics.

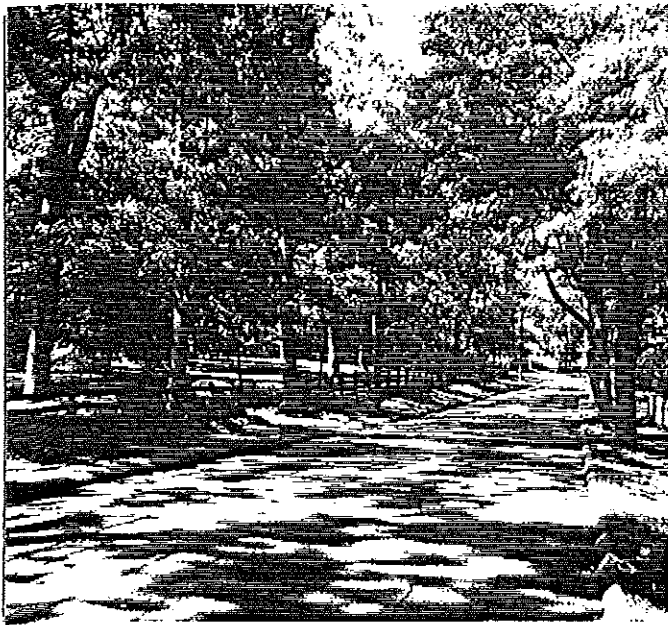
Description - This is a primarily residential area with buildings that date from the 1830's to the 1930's. Various architectural styles are represented in the district of very large and fine houses. Lots in the district are generally large with well maintained landscapes. A small cemetery, associated with the original Baptist Church building, the existing Baptist Church, and a portion of a black neighborhood is also a part of the district. The most common styles of architecture in the district are the Neo-Classical and Bungalow. In the western part of the district, the buildings are much more imposing in nature and are straightforward and simple in design. Victorian and Colonial Revival influences can also be in this

district. Most of the district is well landscaped with a naturalistic appearance.

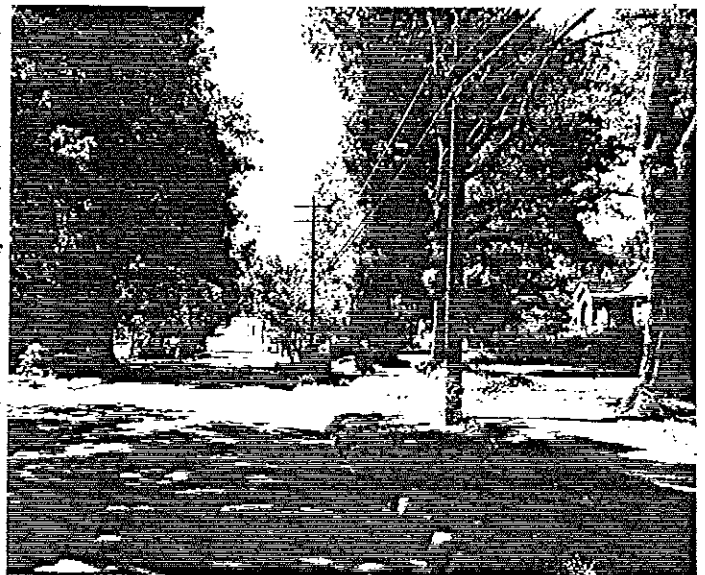
Description - The East Marable District is a late 19th and early 20th century residential area. It developed as a middle class residential neighborhood to the north of the North Broad Street. The buildings in the district are all located on the north side of East Marable Street and are generally one-story, modest frame houses. The racial makeup of the area was white, and was separated by the railroad from the black residential section to the west. The houses maintain a uniform setback fairly close to the street and are Victorian in nature. They have large porches, decorative scrollwork, asymmetrical floor plans, and turned balusters. The 20th century buildings are simpler and have Bungalow features.

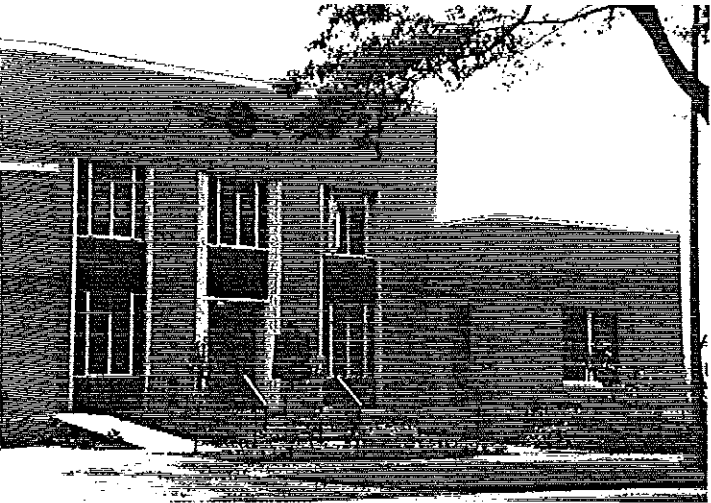
Monroe City Hall

This building, located at 227 South Broad Street, is important because it represents a style in stark contrast to other buildings in Monroe. Built in 1939, as a WPA project, it represents Monroe looking to the future at the end of the Depression. It consists of a two-story Art Deco block building with projecting one-story wings on both sides and metal windows typical of the era.

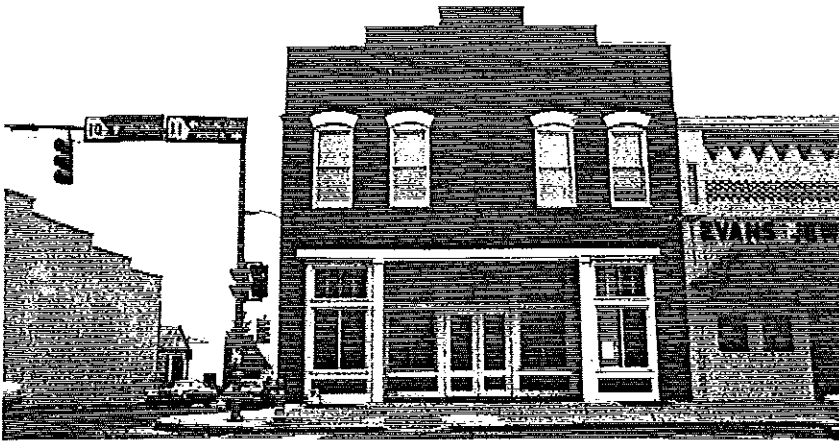
A typical commercial building features a facade with an ornamental cornice serving as a cap to the building; double-hung windows on upper floors, the type varies with the style of the building; pilasters which express the structural bays of the building; a continuous lintel which separates upper floors from the storefront; and a storefront contained under the lintel and between masonry piers.

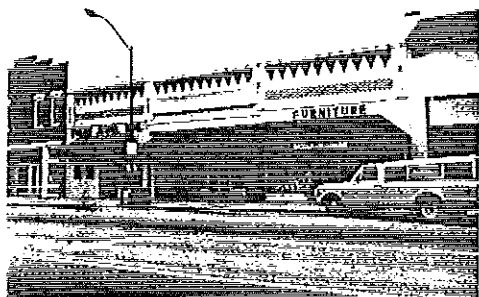
Vernacular - The majority of the buildings in the district are one and two-story brick buildings with brick corbelling in the cornices.

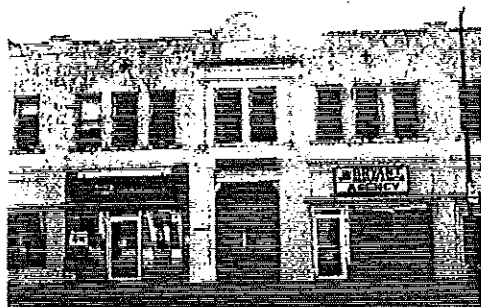
Spanish Colonial - There is one building in Monroe's downtown which has characteristics of the Mediterranean style. Although the structure is of brick, it has the appearance of stucco. The structure also has a Spanish style parapet and ornamentation.

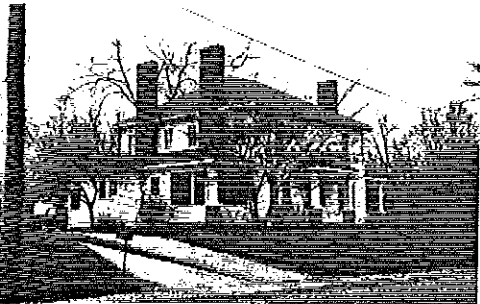
Four Square Plan - The Four Square house plan has a boxlike shape and hipped roof. It is a simple and practical style and is easily adaptable to many styles with a change in window style, porch detail, or exterior material. The plan could accommodate one or two-story dwelling and was used heavily in Monroe's historic residential districts.

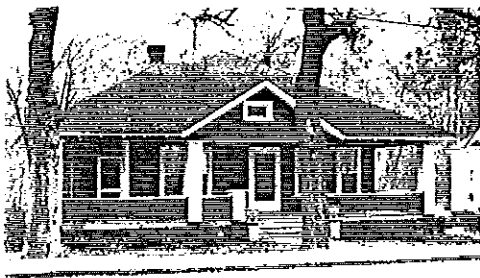
Bungalow - The Bungalow house plan is very prevalent in Monroe's residential areas. The plan consists of a small, usually one and a half story dwelling with a low-pitched gable roof and an asymmetrical interior floor plan.

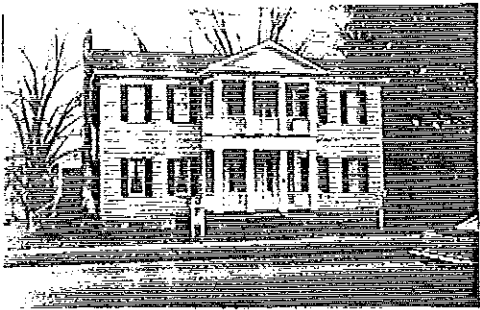
Greek Revival (circa 1820's - 1860's) - The Greek Revival style is evident in Monroe's residential district in vernacular structures. Characteristics include a pedimented portico supported by columns, a transom surrounding the doorway, and wood siding.

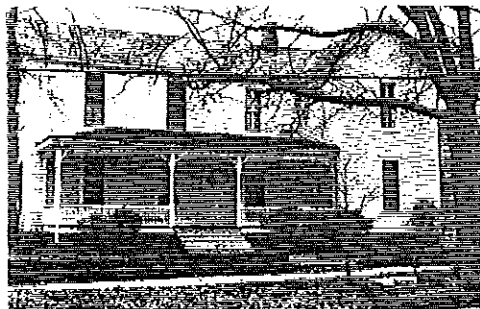
Vernacular Victorian (circa 1880's - 1910) - Some of the same features found on high styled Queen Anne dwellings can also be found on vernacular house types. The ell-shaped house plan often has Victorian details such as gingerbread-work, turned spindles, and elliptical windows.

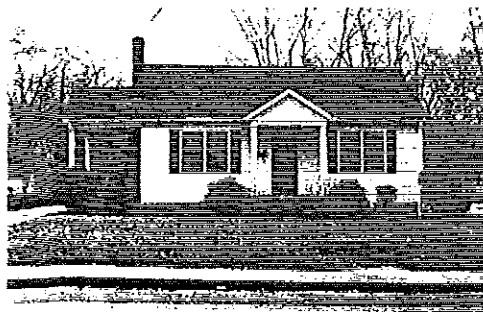
Colonial Revival (circa 1920- 1950) - The Colonial Revival style in a vernacular form, is popular in Monroe's historic residential districts. It is usually a one story dwelling with the following features: shutters, a pedimented stoop or front porch, and wood siding.

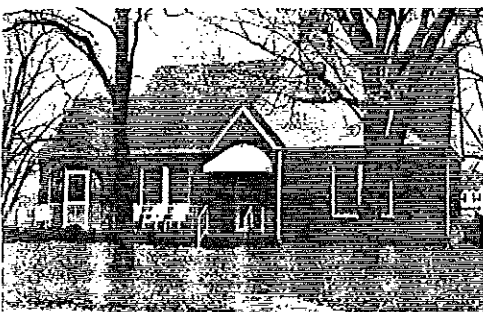
Tudor Revival (circa 1930's - 1950) - The Tudor Revival style is distinctive and easily recognized. The entryway is almost always gabled. The interior floor plan is asymmetrical and the house is usually one or one and a half stories. Some of the features of the Tudor Revival Style are its brick construction, half-timbering, and its steeply pitched gabled roof.

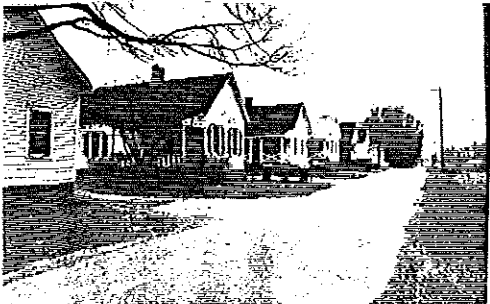
Double Pen with Gabled Roof (facing the street) - This house type is the same as above with the exception that the side gable is oriented to the street, and in this case also the railroad. This is a unique mill village house type.

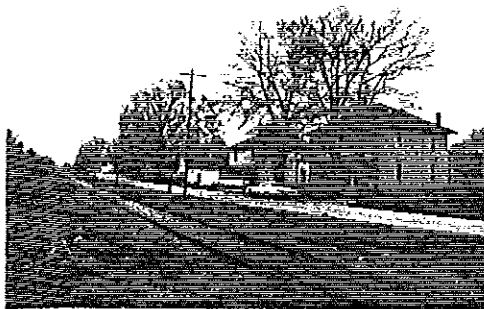
Four Square - These houses illustrate the rarely seen two-story mill village dwelling. The plan is a simple boxlike house with hipped roof, one story porch roof, and a pier foundation.

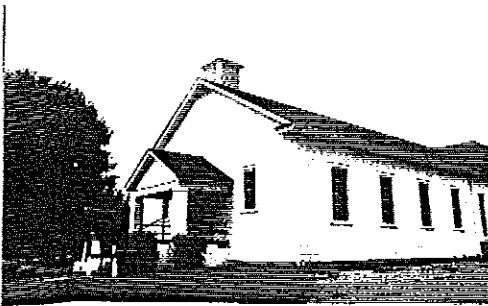
Churches - Several churches located within the district served the spiritual needs of the district's residents.

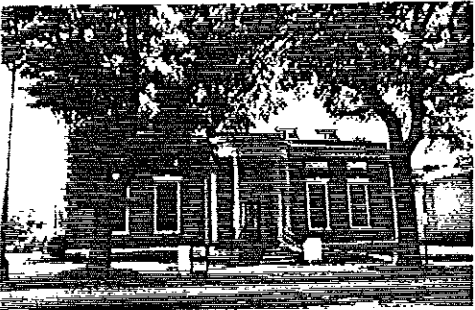
Classical Revival (circa 1895-1950) - Monroe's present day library was built in 1932 and served as the city's post office. The building, constructed of red brick, is classically inspired, with its rounded portico, ordered columns, and rectangular shape.

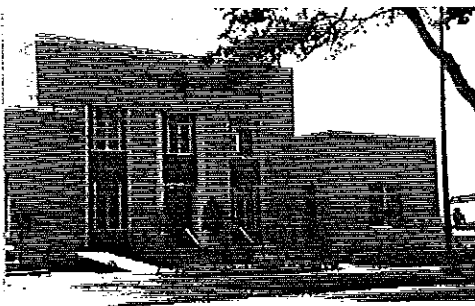
Art Moderne (circa 1920-1940)- City Hall is an example of Art Moderne architecture, built in 1939 as a WPA project. It is the only structure of this style in Monroe. Its characteristics include: squared features, a horizontal tendency, several paned windows, and a smooth exterior texture.

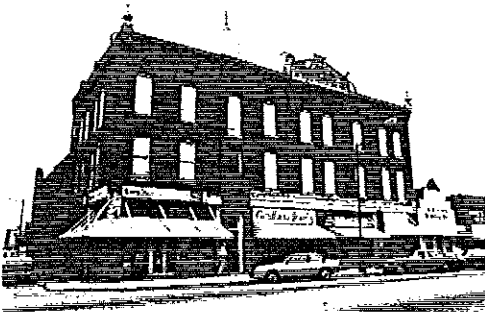
A use for the hotel might include a retail use for the ground floor and office space for the upper floors.

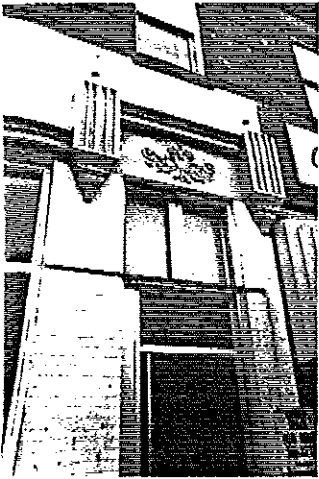
Detailing in tin is a unique aspect of downtown Monroe and should be preserved.

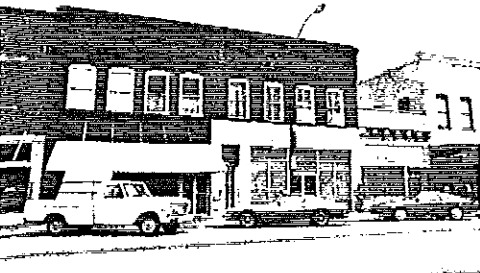
A commercial building should be treated as a whole, although there may be more than one business or office utilizing it. A uniform storefront treatment and color is advisable. This building has been treated in different ways and has a disjointed appearance.

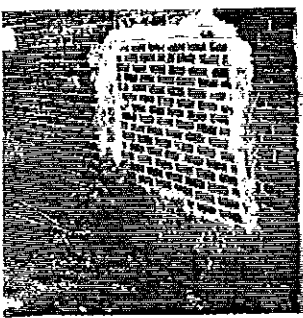
An example of improper masonry repair.

D. Masonry - The large number of brick buildings in this district necessitates special care in masonry repair and sensitive cleaning, which means No sandblasting. The correct procedure is to remove deteriorated mortar by carefully hand-raking the joints to avoid damaging the masonry; duplicating the old mortar in strength, composition, color, and texture; and repointing by duplicating the old mortar joints in width and in joint profile.

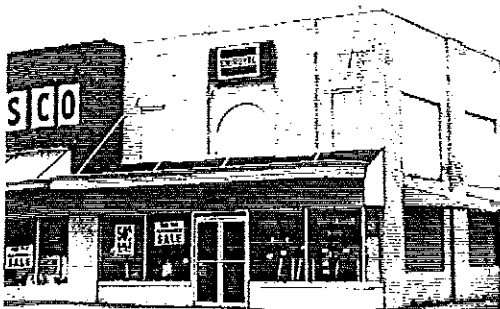
Metal awnings hide the important details associated with historic storefront design.

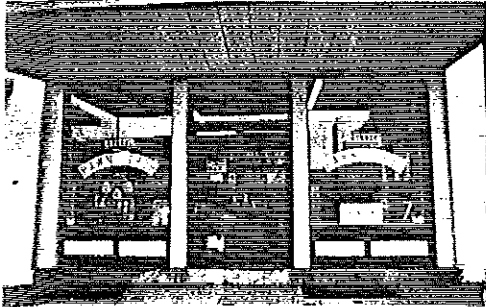
An example of aluminum doors and windows which have been painted a compatible color to keep the historic character of the storefront in tact.

F. Doors and Windows - Every attempt should be made to retain original doors and windows. The addition of aluminum doors and windows is often necessary in commercial districts for security reasons, but can detract from the historic character of the storefront. However, the harsh effect can be softened by painting the aluminum a compatible color.

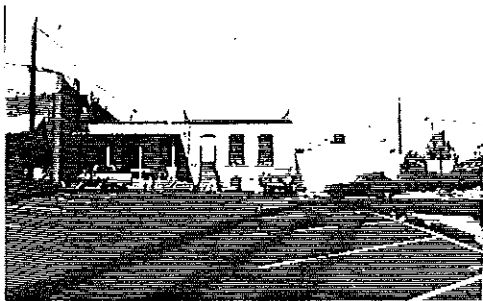
An example of a rear entrance which has been improved to allow more convenient access and also enhance the appearance of the community.

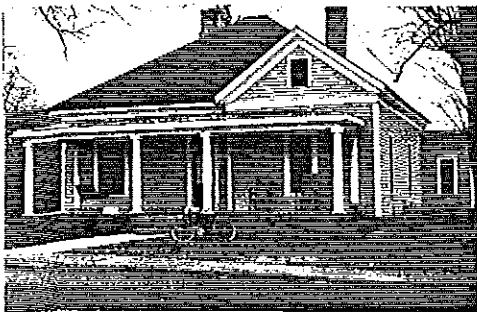
Examples of block infill with vents. This does not preserve the original pier affect because there is no recession of the blocks or delineation between the materials. The result is a heavy looking base which changes the character of the house.

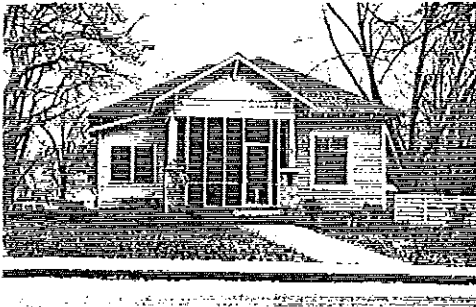
An example of a porch enclosure which has preserved original materials and maintained the open character of the porch space through the use of screening. Equal divisions have been created by the addition of vertical and horizontal supports which relate to the lines of the house.

C. The Porch - The porch is a common element in Monroe's residential districts. Enclosing the porch should be handled in a manner which preserves its open character and the original materials. Preservation of the open character is accomplished through the use of transparent materials, such as wire mesh and glass. The spaces created through the addition of screen supports should relate to the overall lines of the structure. It is also important in maintaining the original character of the porch to use compatible or original materials when replacing deteriorated porch posts, railing, and flooring.

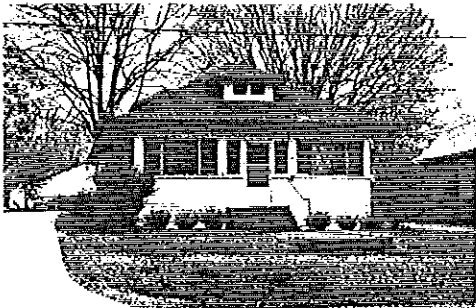
This enclosure results in concealing the original front porch and is discouraged. The new solid base causes a loss in the former open character of the porch space.

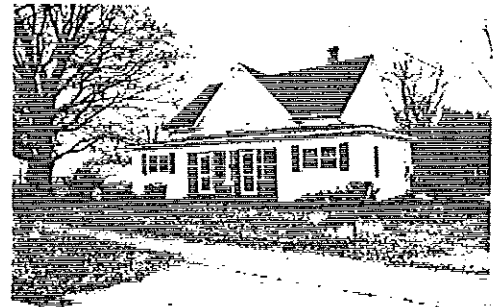
Although this enclosure partially utilizes screening, it also consists of solid material and inappropriate windows. The historical character of the house has been lost as well as the open character of the original porch space.

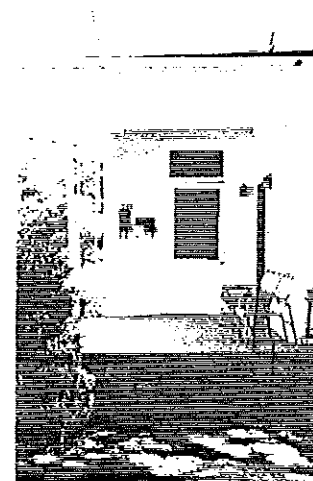
An example of a porch floor which was originally wood and has been replaced with cement. The result is one which is not compatible with the rest of the porch.

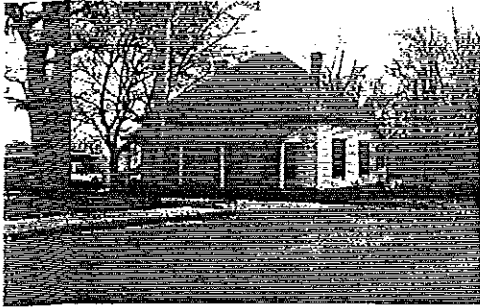
An example of applied shutters which are not appropriate to this house.

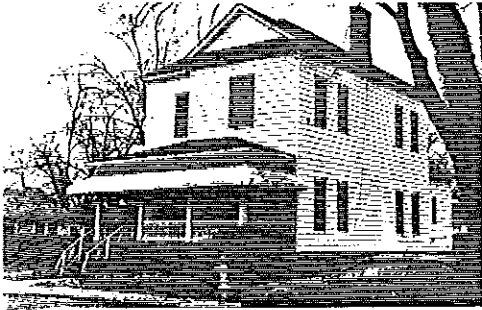
Example of vinyl siding applied to a historic residence which obscures the original details. These details are now flush against the vinyl siding and no relief is evident. Proper use of vinyl siding applied to an historic residence does not obscure the original details and duplicates the original width of the weatherboard.

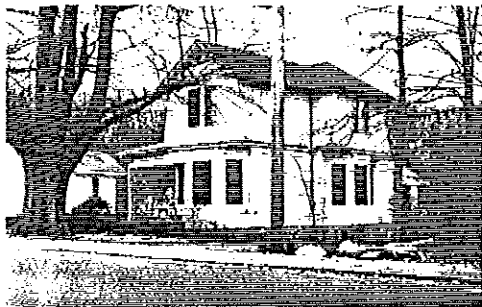
The addition of asbestos shingles is also discouraged, since it changes the appearance of an original dwelling sheathed in clapboard.

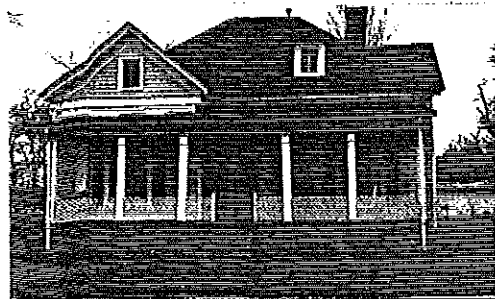
An example of total roof replacement with asbestos shingles. This is a typical replacement material in Monroe. It is important that the shingle color be compatible to the house.

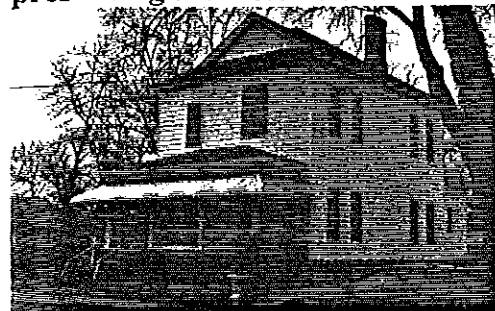
Compatible addition is at the rear of the structure (away from public view), in proportion with original structure, and materials similar to the original structure.

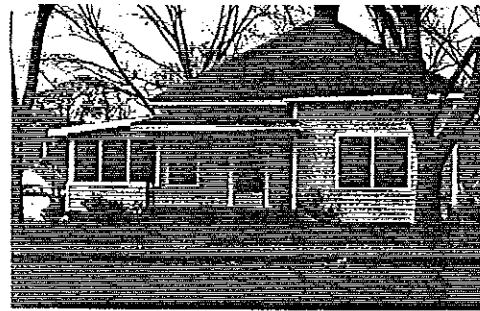
An example of an addition which alters the form of the historic structure on its street facade.

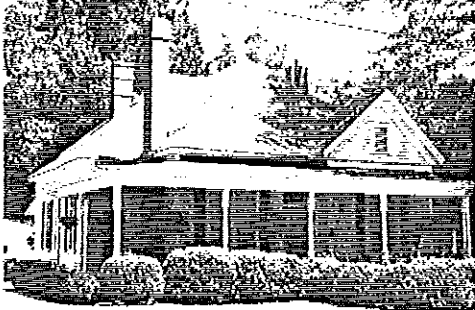
The built-in box gutter located along the porch cornice of this structure is a typical type found in the district.

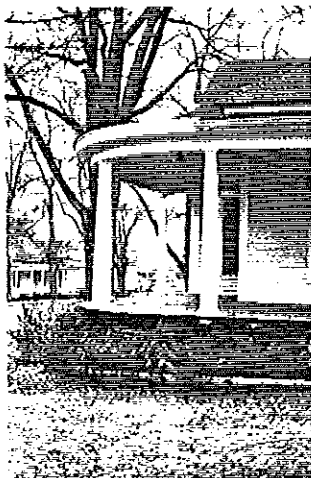
The hanging gutter illustrated has an abrupt break which is a visual intrusion to the otherwise fine lines of this structure.

J. Gutters and Downspouts - Gutters and downspouts are important functional elements of an historic building. Gutters and downspouts should be designed to carry the volume of roof runoff and kept free of debris. From a visual perspective, gutters should follow the cornice lines of the house and be of a compatible color to the structure. Downspouts placed in nonobtrusive locations, such as along porch posts or at the corners of the structure.

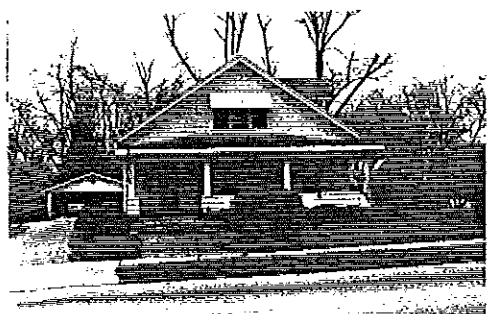
An example of a garage of compatible form and scale to the residence. The gable orientation of the garage repeats the gable form of the house. The materials used in the garage are also compatible. The house receives visual attention instead of the garage.

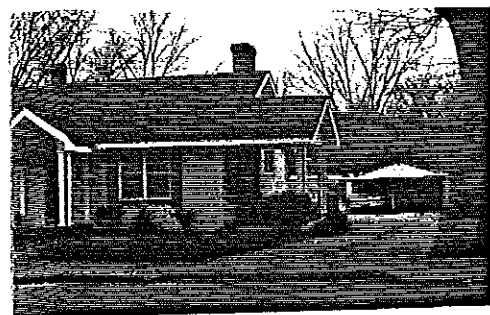
An example of a garage which is not compatible with the original structure. It has no relation to the style or roof form of the house.

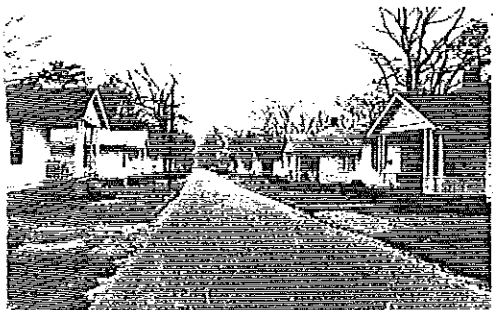
Rows of open front porches are a commonplace element in the district.

B. The Front Porch - The open front porch is a common element on houses throughout the district. Porches were typically raised with wood flooring, simple wood railings and posts, and modest detailing, such as sawtooth trim and exposed rafter ends. The plain style detailing, open character and predominant use of wood should be retained on porches within the mill district.

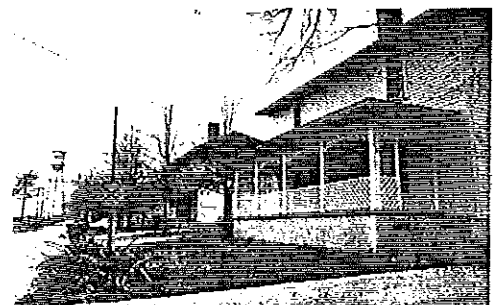
The addition of lattice is out of character with the more modest porch detailing found on structures throughout the district.

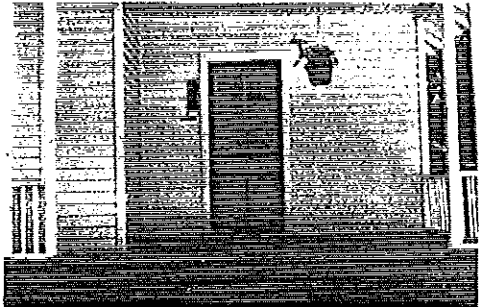
An example of wood flooring as an original element of the front porch.

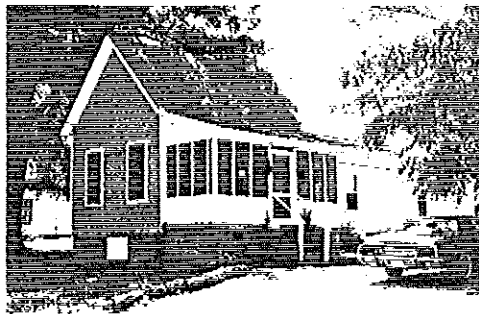
An example of an open porch later screened in. Although transparent screening material has been used, the added solid base makes this porch bottom-heavy and alters the open character of the original porch.

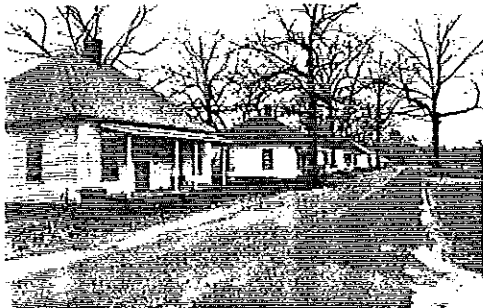
The addition of polyurethane sheets to windows and doors of the dwelling in the foreground is a temporary method of weatherproofing a structure that does not harm the historic material.

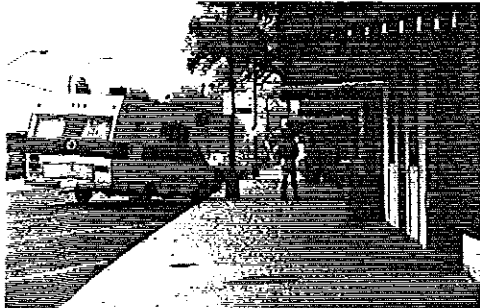
An example of new, expansive, concrete paving which creates a glaring surface with little visual interest. An important element of the historic streetscape, the curbing, is missing in the new sidewalk.

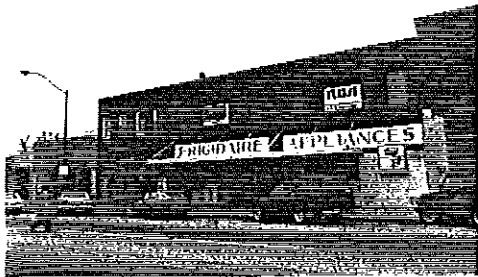
The scale of this sign is too large for the building.

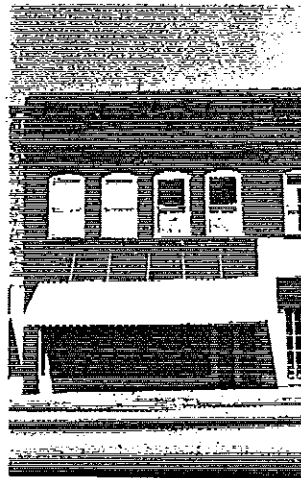
An example of potential sign locations - on the cornice of an historic building or in the space above the transom in a storefront.

D. Signage - Signage should be subordinate to the architecture of the building and sized for legibility at a reasonable distance, particularly to pedestrians and motorists passing through the town center. Appropriate locations for signage set flush on a commercial building is the lintel space which separates the storefront from the upper floor and the space above the transom in the storefront. Some unique locations for signage includes the window or the entrance floor.

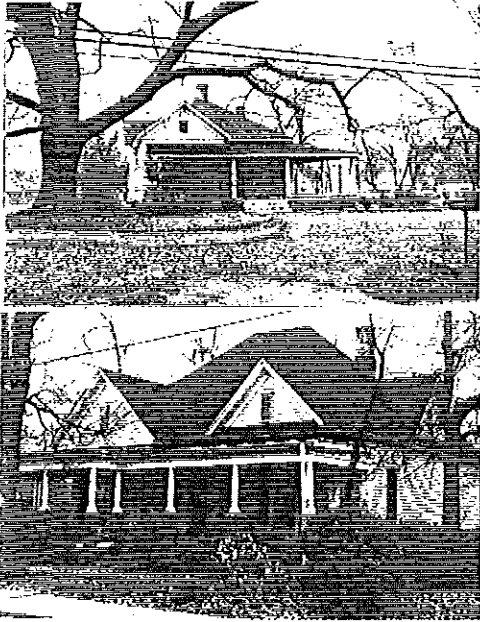
An example of an historic landscape treatment. Note the sawtooth edging, a typical landscape edging material from the historic period.

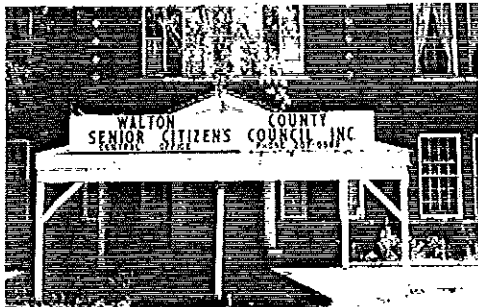
An example of signage on a former school structure that is out of scale with the neighborhood and building. A more appropriate location for the signage would be in the front yard along the street so that it is more visible to passers without distracting from the character of the building.

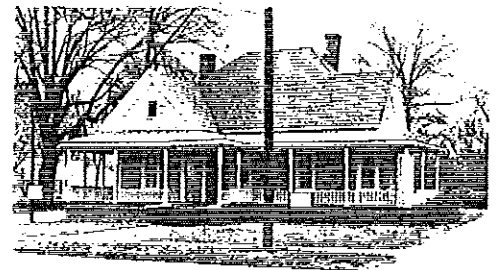
An example of favorable signage in a residential district. The sign does not detract from the house but yet it is plainly visible from the street. It is also in keeping with the streetscape and residential quality of the area.

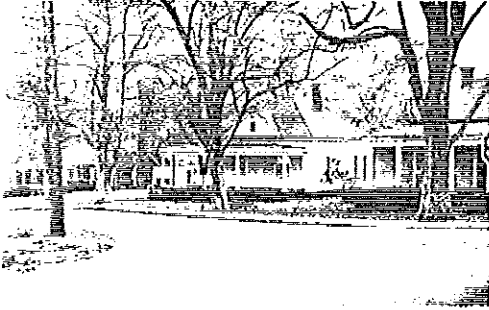
The character of Monroe's residential streetscape is that of uniform setbacks, frame residences, and large hardwood street trees. The street trees assist in creating a livable residential environment.

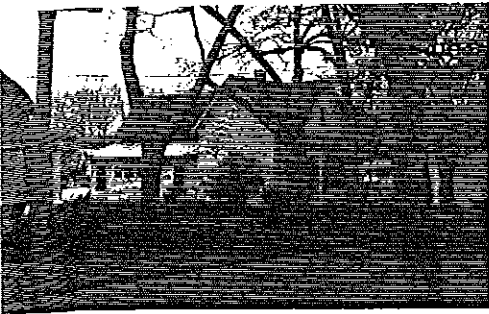
Most historic districts in Monroe are lined with mature trees which give the city a pleasant and residential feeling. In many cases, the preservation of street trees will be a responsibility of the private homeowner since many trees are located in the front yards of dwellings adjacent to the street.

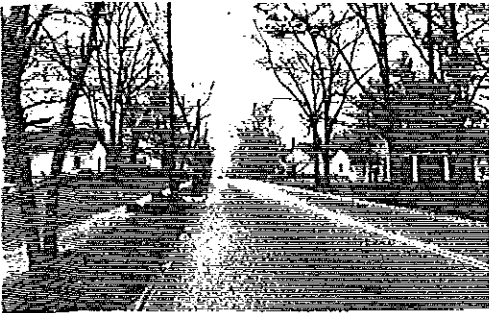
Trees along major roads, such as SR 11, are particularly important. Visitors receive their first impression of the city traveling this route and the trees favorably enhance the streetscape. Power lines along this road make the dogwood tree, which is a low growing variety, a better replacement selection than the taller oak trees.

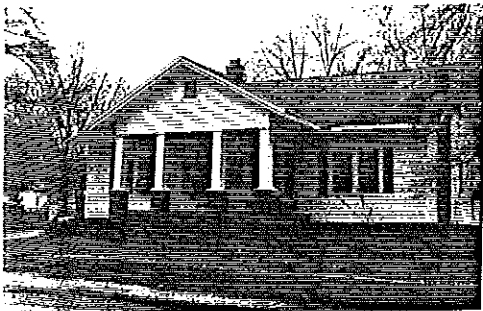
An example of an insensitive placement of an air conditioning unit in the window on the front facade of an historic structure.

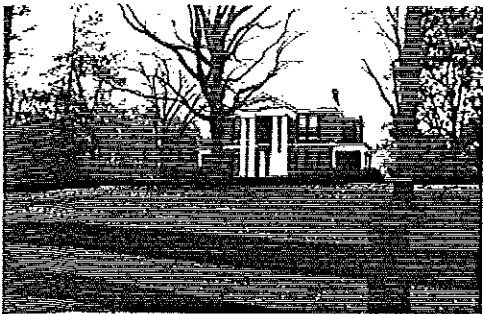
The addition of new buildings to estate properties, such as the McDaniel-Tichenor House located in the McDaniels Street Historic, should recognize and respect the visual dominance of the residential structure.

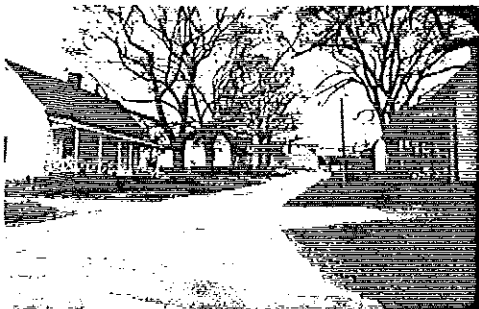
An example of the informal landscape character that typifies the mill district.

A. Streetscape Character- The streetscape character of the mill district is informal with little curbing or sidewalks. The most dominant landscape feature is the large oak trees. These trees should be preserved. Paving should be kept away from tree roots and replacement trees should be of identical varieties. If sidewalks and curbing are added they should be of an informal quality, such as rolled curbing.

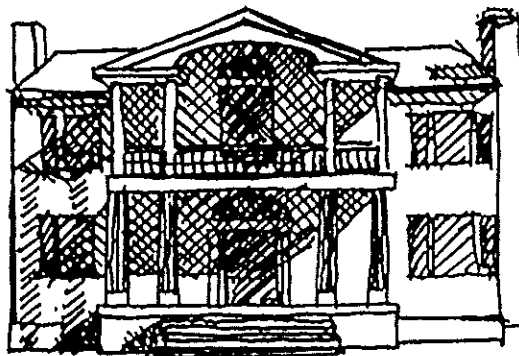
Recognize the relationship of facade elements to the scale of a person. - Identify the scale of doors, windows, overhangs, etc. of properties within the area of influence to scale of a person. Pursue the use of compatibly-scaled elements on the new construction project.
